# Manhole Inspection Summary

Manhole # S55O\_\_029MH

Insp Date: **7/28/08 9:22 AM**

**Location** Address: **1211 s conkling st**

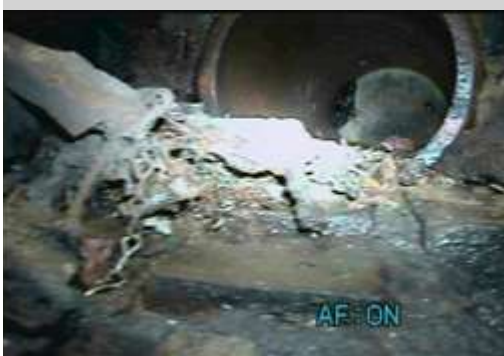
channel debris

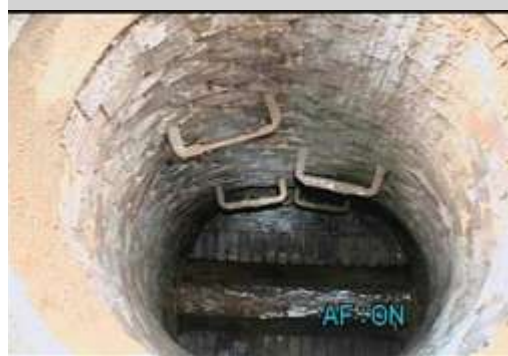
Defect 2

Count: **5** Missing: **0** ☒ **Corroded**

steps

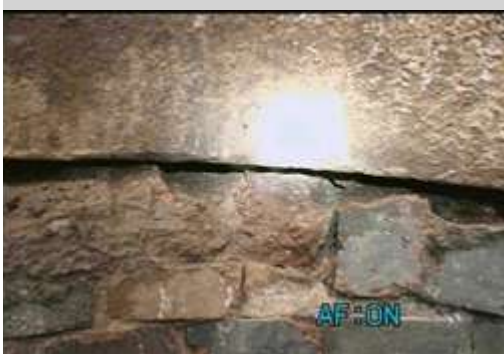
Defect 1

Condition: ☐ Sound ☐ Cracked ☐ Root Intrusion ☒ **Loose Brick** ☒ **Deteriorated**

loose bricks, deteriorated, frame adj

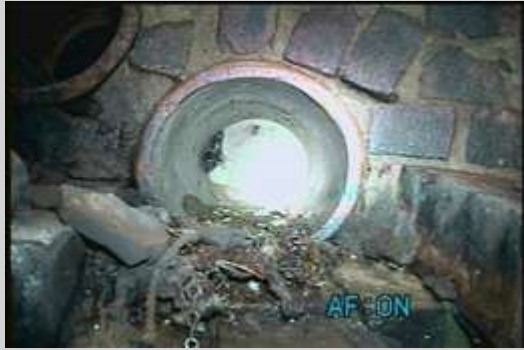
9 O'Clock Inflow

Deposits: ☐ None ☐ Mud ☐ Sludge ☒ **Debris** ☐ Grease

Silt Depth: **1.5** (in.) Deposits Extent: **Light**
